MORRO BAY
NATIONAL ESTUARY PROGRAM

Habitat Protection and Restoration Strategy

August 2024

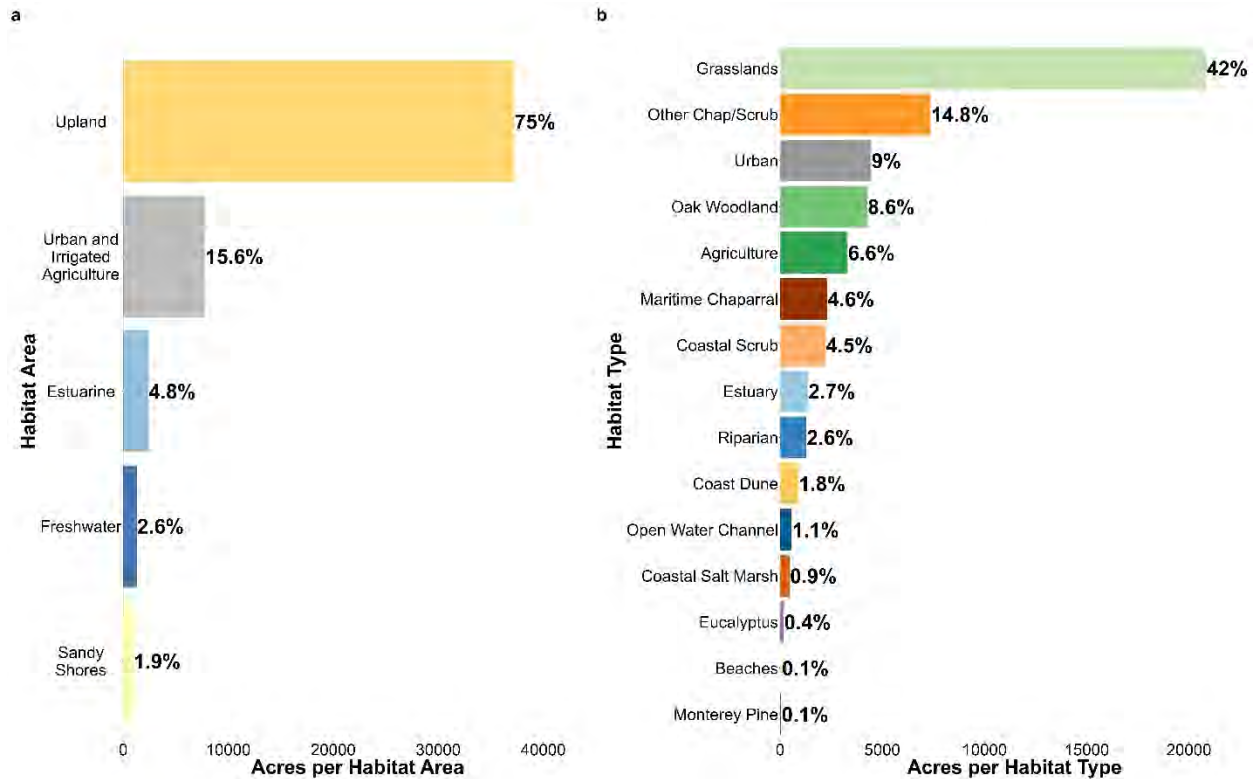
Figure 4. Acres and overall percentage of total watershed acreage within the Morro Bay watershed for each (a) habitat area and (b) habitat type.

Within the over 49,000-acre watershed, 37,216 acres or 75% of the watershed falls within upland habitat area (Figure 2; Figure 4). Irrigated agriculture and urban development cover 7,755 acres of the watershed, approximately 16% of the total watershed area. Estuarine habitat covers 2,391 acres, around 5% of the watershed area. Freshwater covers 1,275 acres, around 3% of the watershed, and sandy shores covers 957 acres, around 2% of the watershed. Grasslands are the most dominant habitat type within of the watershed with 20,854 acres or 42% of the watershed area (Figure 3; Figure 4).

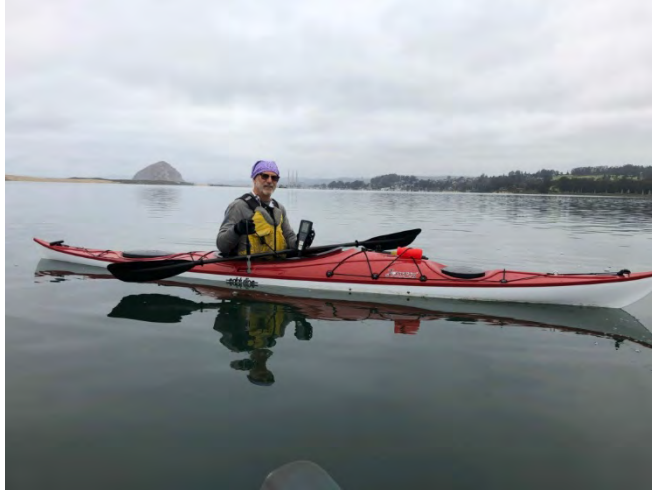
Bay Water Quality Monitoring: Over the past twenty years, the MBNEP has monitored bay water to track long-term conditions. Staff and volunteers collect and analyze water samples for bacteria at bay shoreline sites popular for recreation in partnership with Cuesta College. The MBNEP volunteers measure dissolved oxygen at various locations around the bay. The data is shared in the triennial State of Bay Report as well as through an annual bay health memo. The data is also submitted to the State Water Resources Control Board’s California Environmental Data Exchange Network (CEDEN) for use by the state for assessments and progress tracking. The MBNEP has supported Cal Poly water quality stations in the front and back of the bay since 2016 and 2019, respectively.

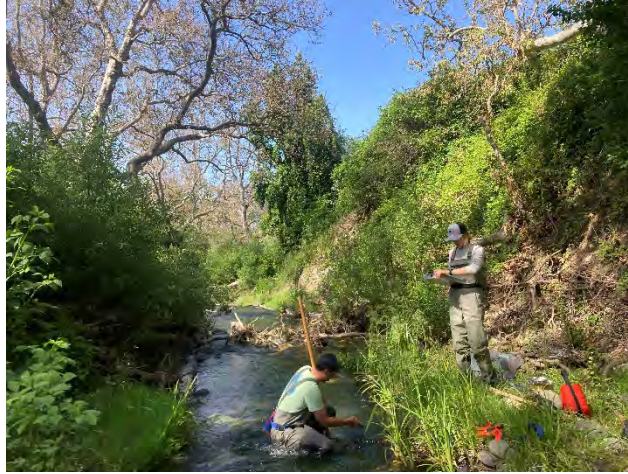
Bioassessment Monitoring: The MBNEP has conducted annual bioassessment monitoring for the past two decades to evaluate creek health and changing conditions in the watershed. Each survey involves gathering around 1,500 measurements to assess stream conditions. Each measurement helps determine if the creek can support sensitive aquatic species. The surveys are completed with the help of volunteers, Watershed Stewards Program Corpsmembers, and more recently with students from Cal Poly's Natural Resources Management and Environmental Sciences Department. Results are posted annually to CEDEN.

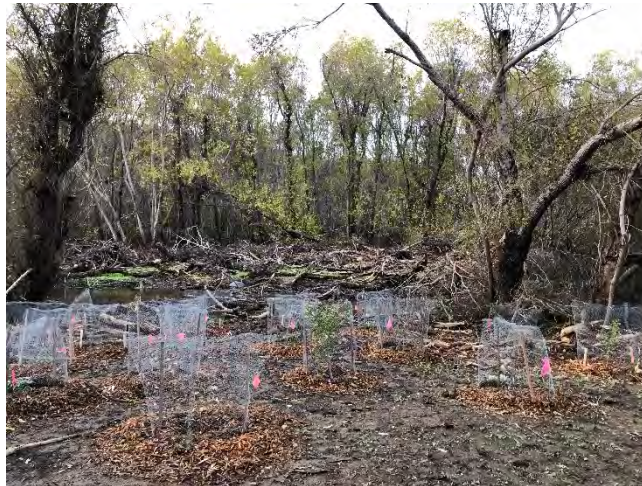
Floodplain Enhancement: The MBNEP has supported three major floodplain enhancement projects within the watershed. The MBNEP partnered with CSLRCD to support restoration of Chorro Flats and Los Osos Creek Wetlands Preserve. Overall, the projects improved 170 acres of floodplain and wetland habitat for sensitive species and improved groundwater recharge and sediment capture. CCER Floodplain Restoration Project reconnected over four acres of floodplain habitat along Chorro Creek and planted over 1,000 native plants to improve native riparian vegetation. These projects continue to be monitored and additional native plantings and adaptive management are being developed with site and climatic changes.

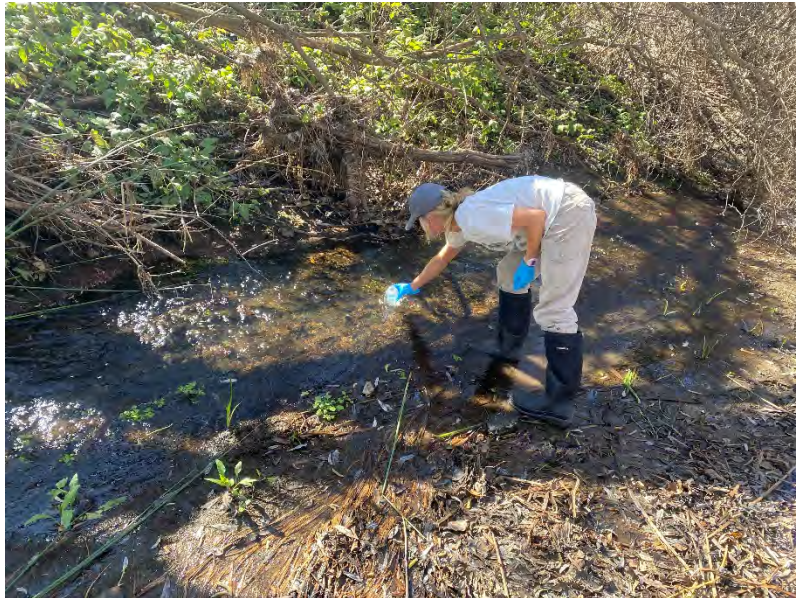
Monitoring of Grazing BMPs: The MBNEP monitors water quality parameters following implementation of grazing best management practices. After riparian fencing was installed along San Luisito Creek, monitoring program tracked bacterial levels in the creek and tracked resulting water quality improvements.

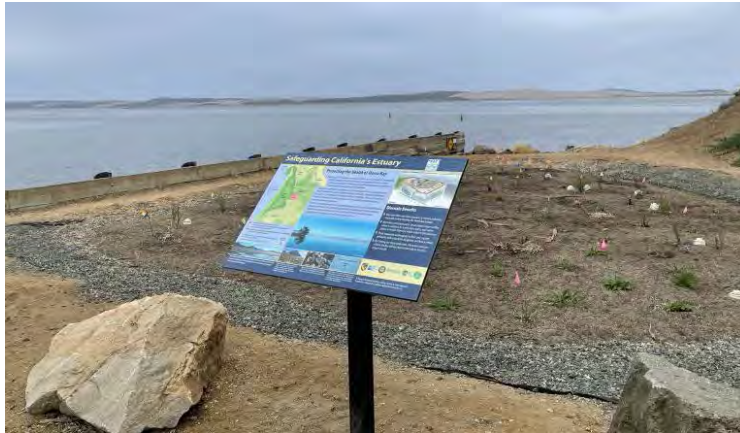
Stormwater Improvement Projects: MBNEP has conducted stormwater improvement projects to improve water quality entering both the estuary and creeks. MBNEP worked with CSP and the California Marine Sanctuary Foundation to obtain grant funding from the Ocean Protection Council to design and construct an improved parking lot and BMP structures, including bioswale and a sediment trap structure, to improve water quality of parking lot runoff. Construction was completed in the spring of 2022. The project also involved monitoring the runoff during storms before and after the project installation to track the changes in the water quality. Three additional stormwater improvement projects have also occurred at Camp SLO with MBNEP and partner organizations.
